Manhole Inspection Summary

Manhole # S37UU_008MH

Insp Date: **12/20/06 11:49 AM**

Location Address: **521 28TH ST**

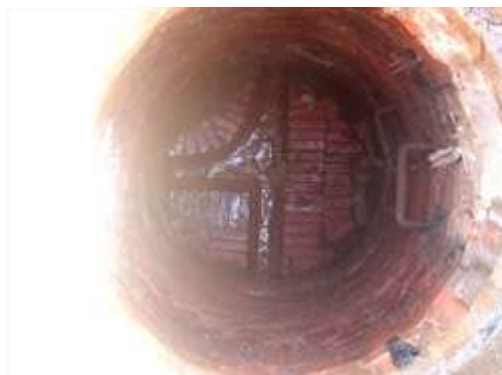
Top View

Corroded and missing steps. Bench debris.

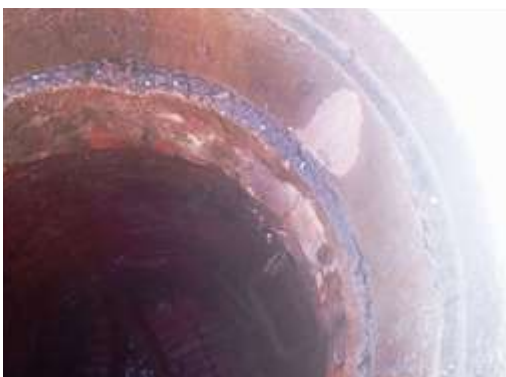
Defect

Frame leaks. Adjustment deterioration and infiltration. Corbel and Barrel infiltration.

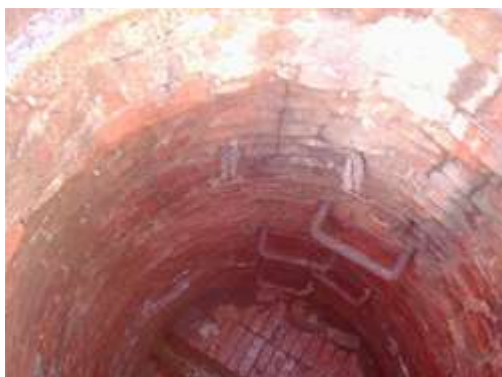
Defect

Frame leaks. Adjustment deterioration and infiltration. Corbel and Barrel infiltration.

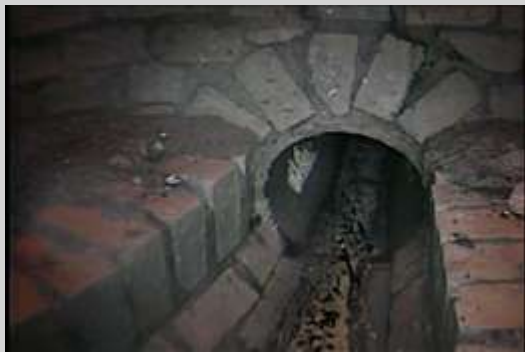
8 in. Circular Gravity Sewer Pipe Out @ 12 O'Clock

Deposits: ☐ None ☒ **Mud** ☐ Sludge ☒ **Debris** ☐ Grease

Silt Depth: **0** (in.) Deposits Extent: **Light**

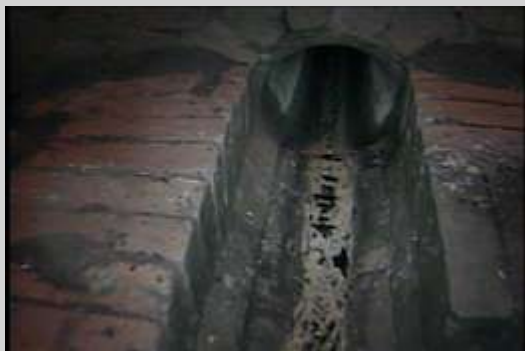
8 in. Circular Gravity Sewer Pipe In @ 6 O'Clock

Infiltration: **Evidence** Pipe Seal Cond: **Unknown**

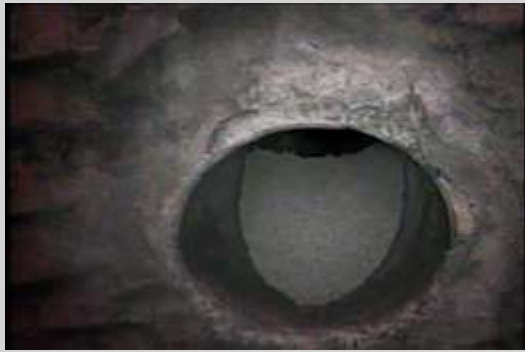
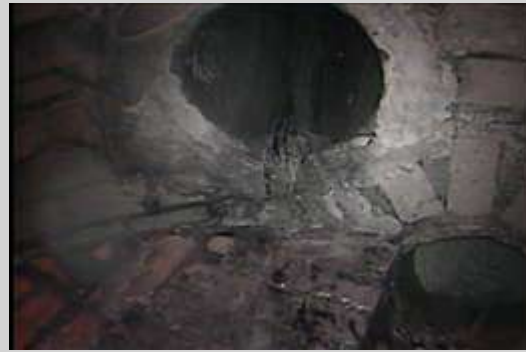
Pipe In @ 8 O'Clock

Infiltration: **Evidence** Pipe Seal Cond: **Unknown**

Drop: **Outside** Rod and Bar
Angled: **Yes** Reading: **8.01** (ft.)
Inv Depth: **9.01** (ft.)
Drop Condition: **Open**
